# Manhole Inspection Summary

Manhole # S31OO1025MH

Insp Date: **4/14/07 10:03 AM**

**Location** Address: **4501 CHARLES ST**

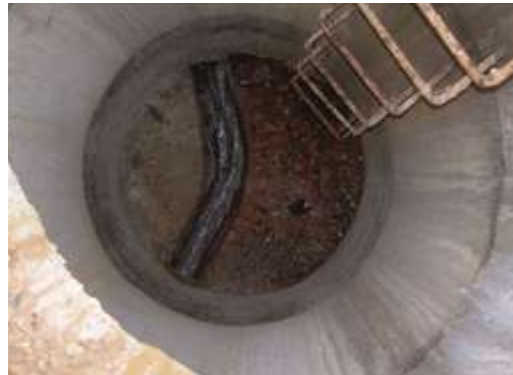
Top View

Barrel infiltration. Bench debris.

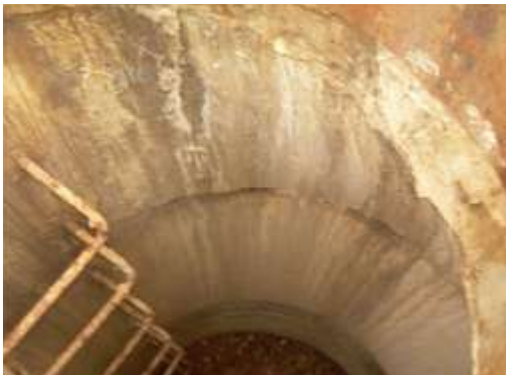
Defect

Frame leaks. Corbel and Barrel infiltration.

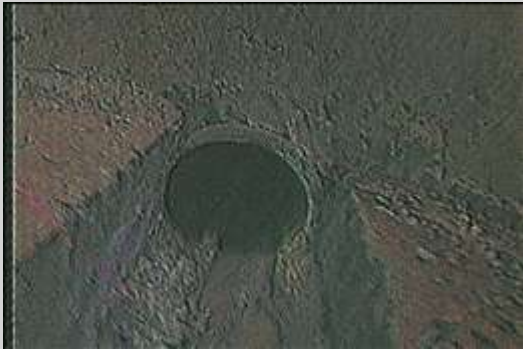
### 8 in. Circular Gravity Sewer Pipe Out @ 12 O'Clock

Deposits: ☐ None ☐ Mud ☐ Sludge ☐ Debris ☒ **Grease**

Silt Depth: **0** (in.) Deposits Extent: **Light**

Infiltration: **Evidence** Pipe Seal Cond: **Cracked**

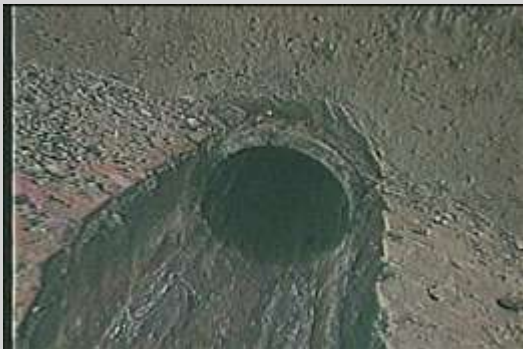
### 8 in. Circular Gravity Sewer Pipe In @ 7 O'Clock

Deposits: ☐ None ☐ Mud ☐ Sludge ☐ Debris ☒ **Grease**

Silt Depth: **0** (in.) Deposits Extent: **Light**

Infiltration: **Evidence** Pipe Seal Cond: **Unknown**
